MARINE INVESTIGATION REPORT
M00N0098

GROUNDING

TANKER *MOKAMI*
BRIDGES PASSAGE, LABRADOR
31 OCTOBER 2000

Report Number M00N0098

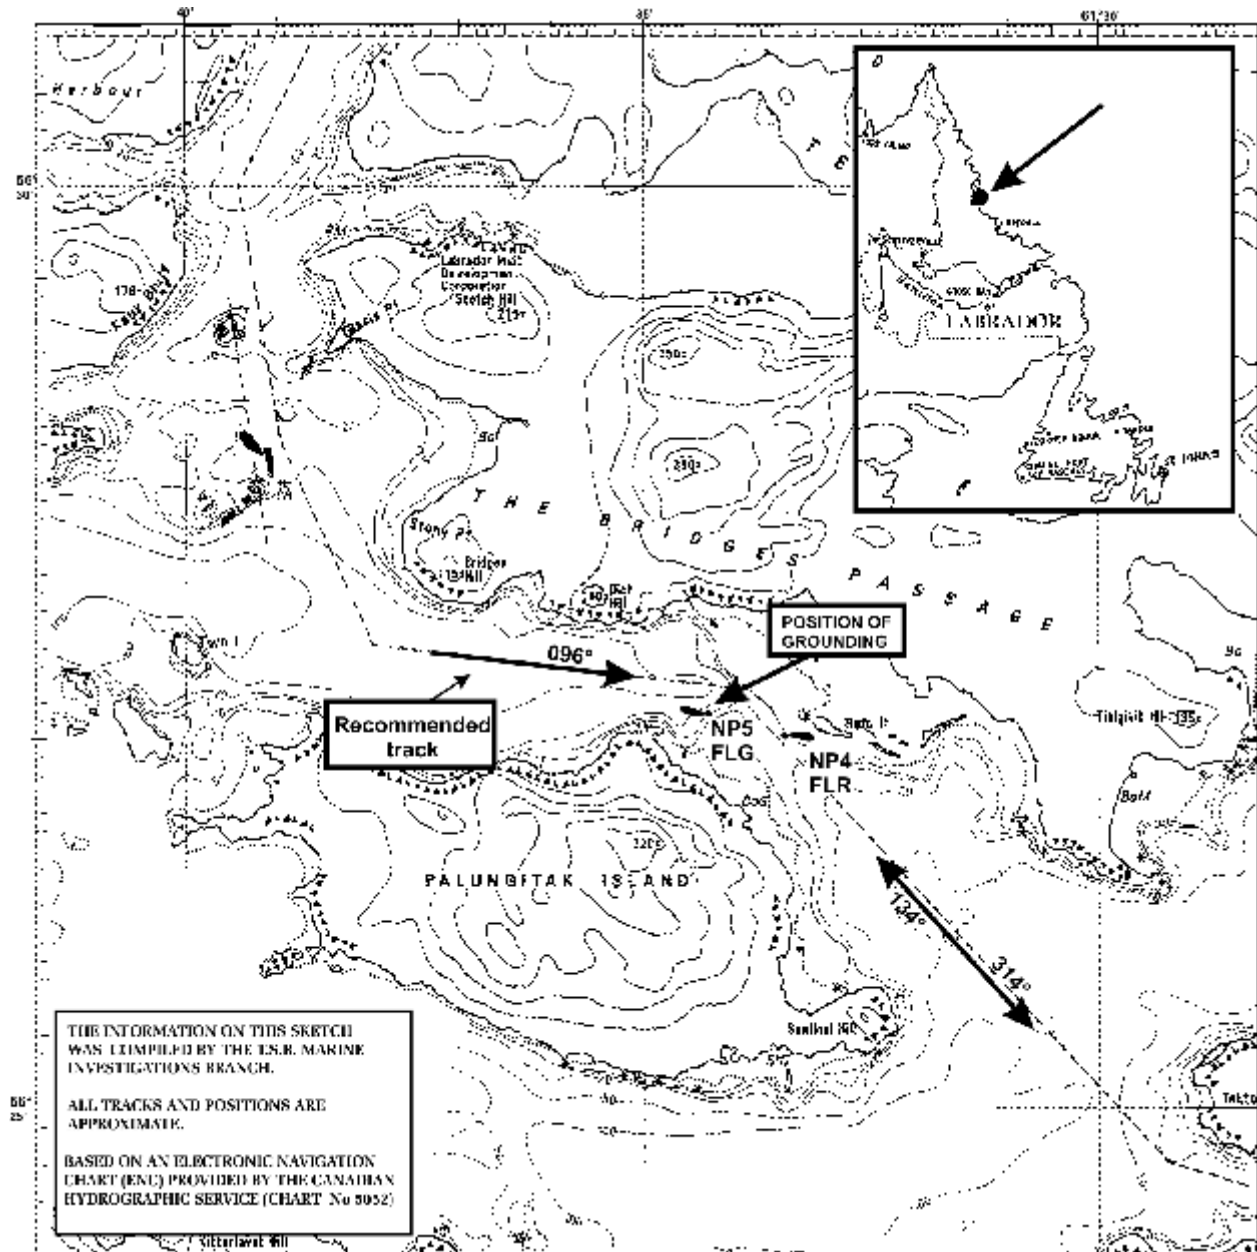
Figure 1. Sketch of the area

With the buoy NP5 abeam 130 m distant and Rain Islet at 5.5 cables, the OOW ordered course alteration in increments to 105°, 110°, 120° before steadying on a course of 134° as per the recommended track. At about this time, the vessel ran aground at 1549, approximately 200 m NE of buoy NP5 (see Figure 2). The vessel sustained severe damage to the hull structure. The cargo tanks were holed, causing minor pollution.

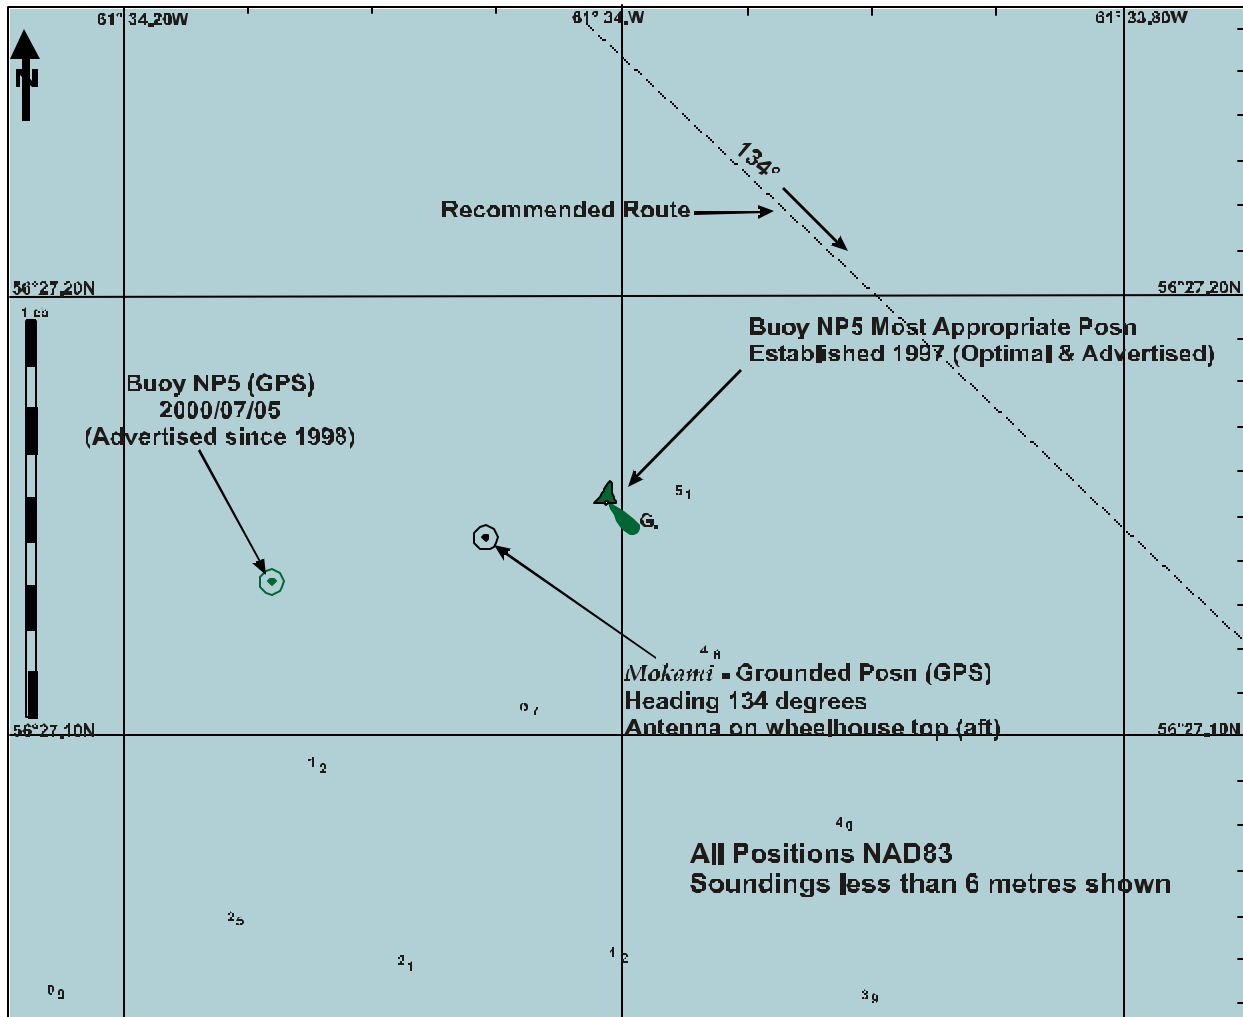
Figure 2. CHS Vector Chart No. CA 409425 (Courtesy NDI)

- 18/07/1997: According to standard practices, buoy NP5 was established in optimal position⁷ by Canadian Coast Guard ship *CCGS J.E. Bernier* following on-site assessment. It was positioned on the northeast corner of a bank extending northeasterly from Palungitak Island at 56° 27' .050 N, 061° 34' .180 W referred to the orphan datum existing on CHS chart No. 4748 -- Bridges Passage Inset.⁸ A BSR was submitted to the regional MNS program office. The “advertised position” of the buoy was the “optimal position” (see Figure 2). This position as plotted is corrected to NAD 83.

- The navigation team relied on buoy NP 5, which was on its advertised position, 160 m west of the optimal position established in 1997. The team relied on the buoy to alter the vessel's course to the exclusion of other visual/electronic cues, in spite of various navigational publications warning mariners that buoys can be out of position and that caution should be exercised in using buoys as an aid to navigation.¹¹

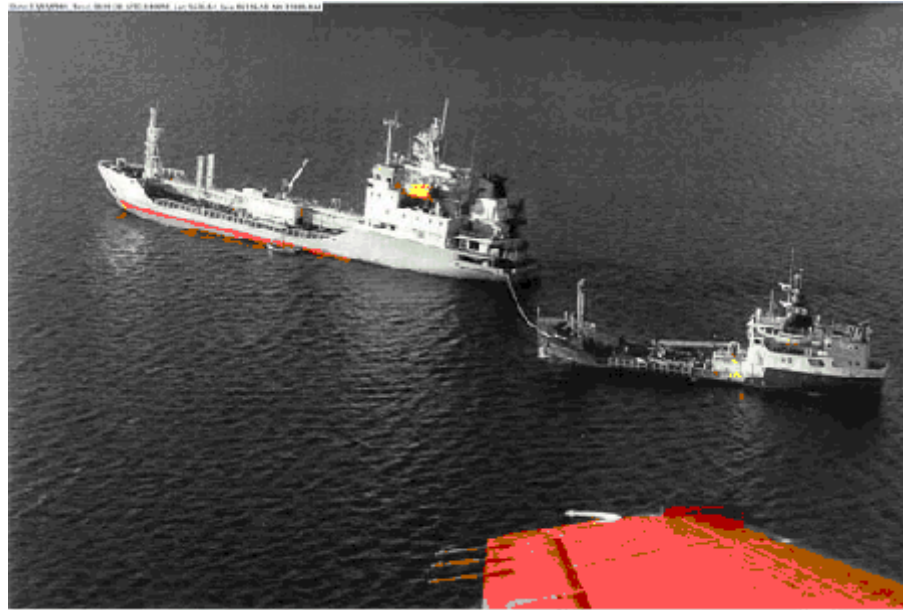
Photograph 1. MV *Mokami* aground - cargo being transferred to the *Sybil W*

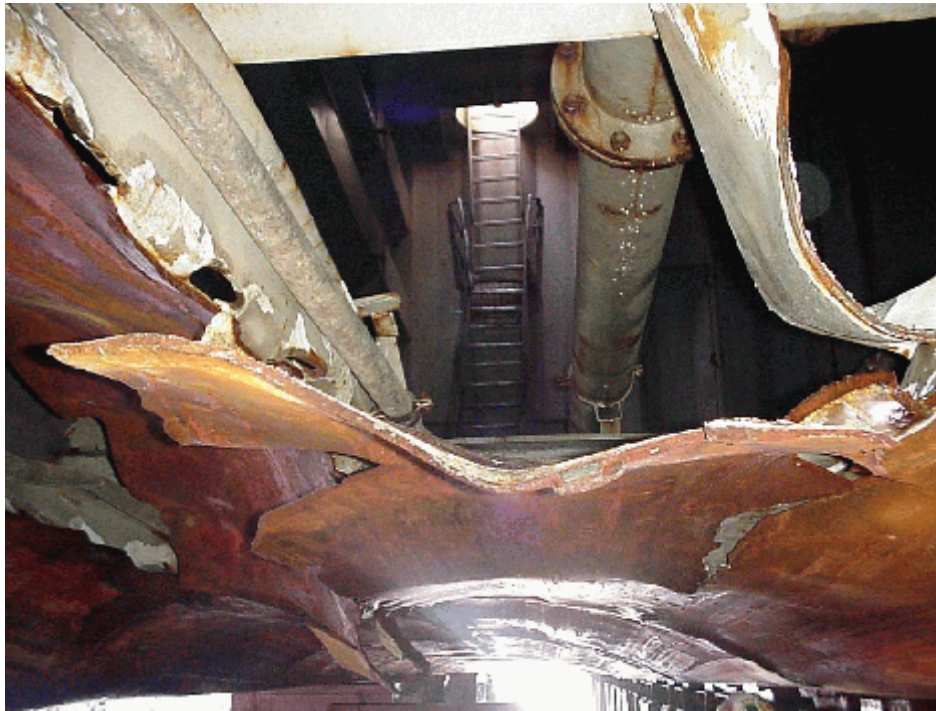
Photograph 2. Bottom damage to the MV *Mokami*
